# Annual Cobot

## Performance Check DEMO

**Serial number:** 20195099990

**Date of the report** : 11. August 2022 10:57

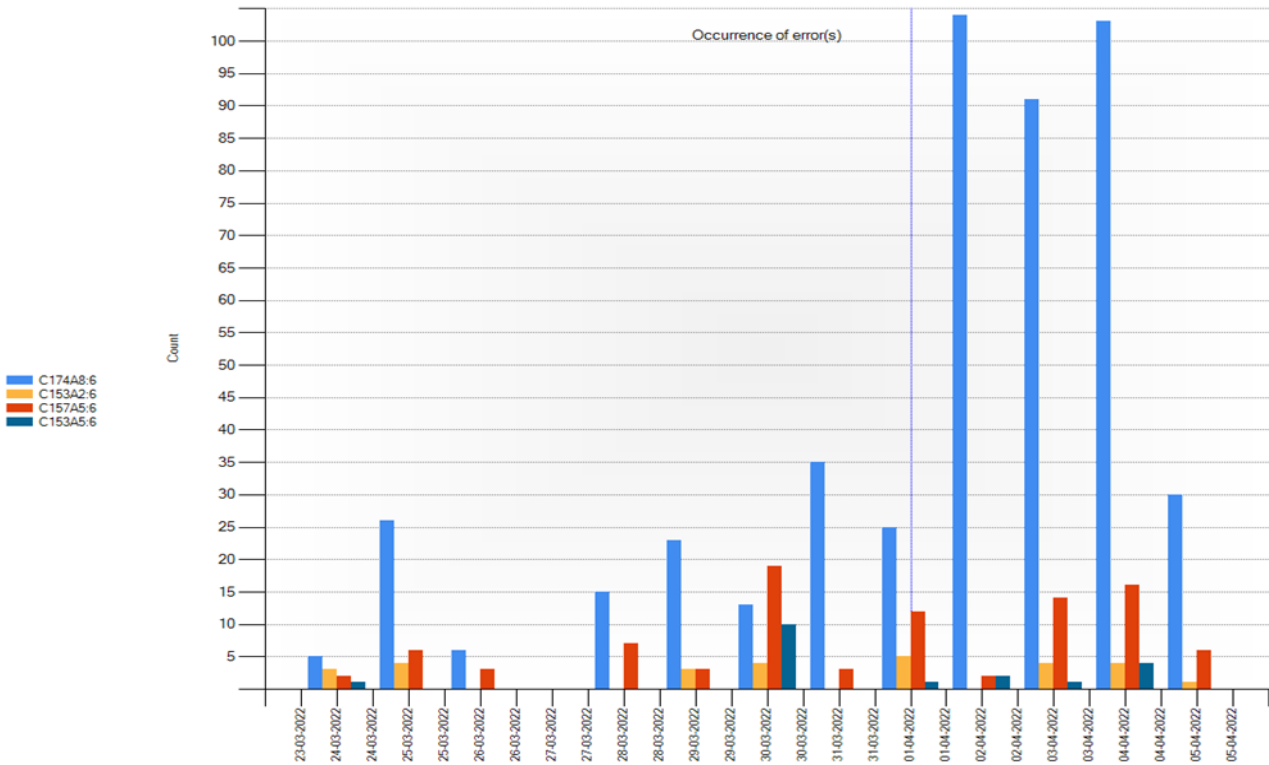
# Log statistics

Error code	Description	First	Last	Count
C153	Position deviates from path. Robot could not follow the path, either there was a collision, or a setting was incorrect. If protective stops occur frequently, resolve the cause. Make sure no objects are in the path, check payload, center of gravity and acceleration settings.	2022-03-24	2022-04-05	116
C157	Collision detected by joint. Robot could not follow the path, either there was a collision, or a setting was incorrect. If protective stops occur frequently, resolve the cause. Make sure no objects are in the path, check payload, center of gravity and acceleration settings.	2022-03-24	2022-04-05	102
C174	Robot motion causes too high jump in joint torques High jumps in joint torque ranges may damage robot hardware. This can be caused by sudden big changes in acceleration in the target trajectory. Use blends or reduce accelerations in the robot motions around where the error was discovered. You can use the script command "pause_on_error_code()" to make the robot stop when this warning occurs, to identify which motion causes the warning.	2022-03-24	2022-04-05	1494

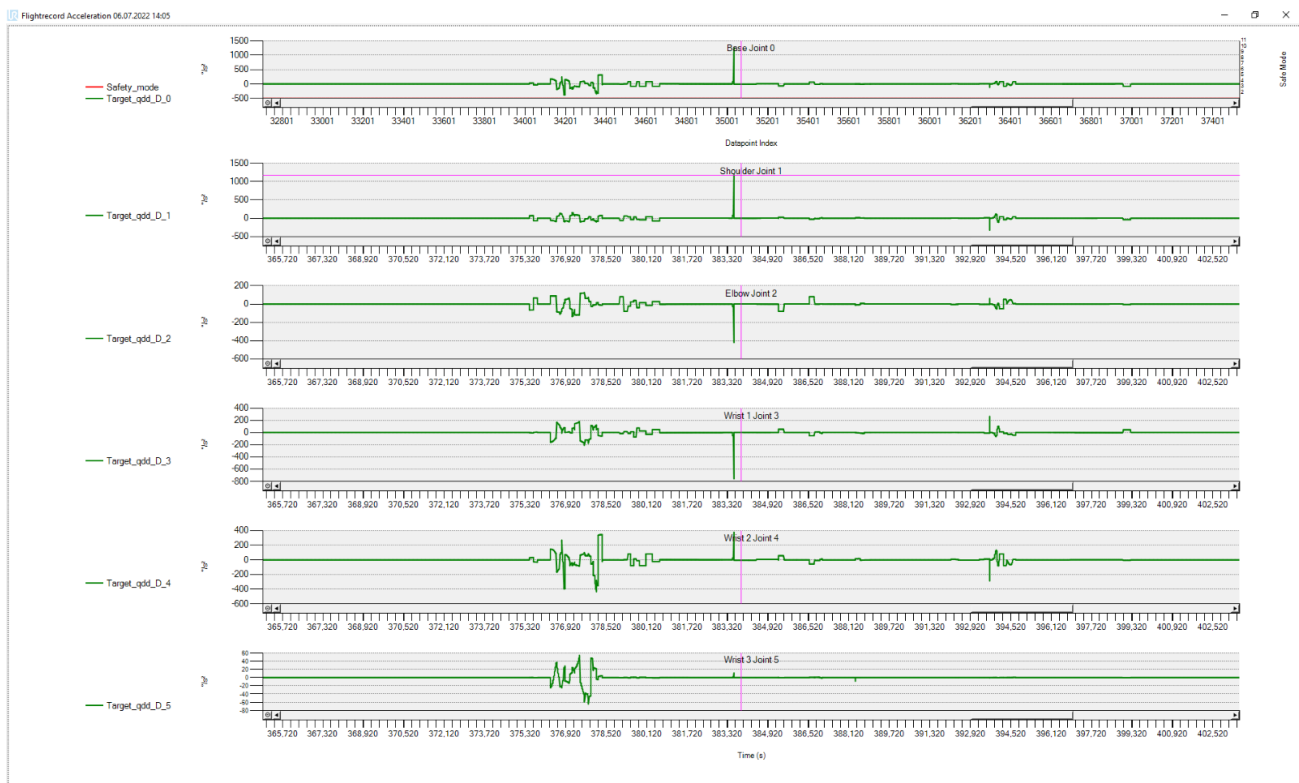
# 4. Avoid high peak accelerations and hard stops

There are unexpected and high acceleration spikes on especially the larger joints - base, shoulder and elbow, as seen in the acceleration plot below.

Make sure that all paths through the robot program generate continuous robot movement, i.e., a blended waypoint should never be followed by a wait command and all aborted movements (e.g., in continuously evaluated if-statements) should be ramped down using the stopj or stopl commands.
